Infrared Cameras and Safety Inspections at Tiger-Sul Facility

Stu Lloyd, Tiger-Sul Plant Manager

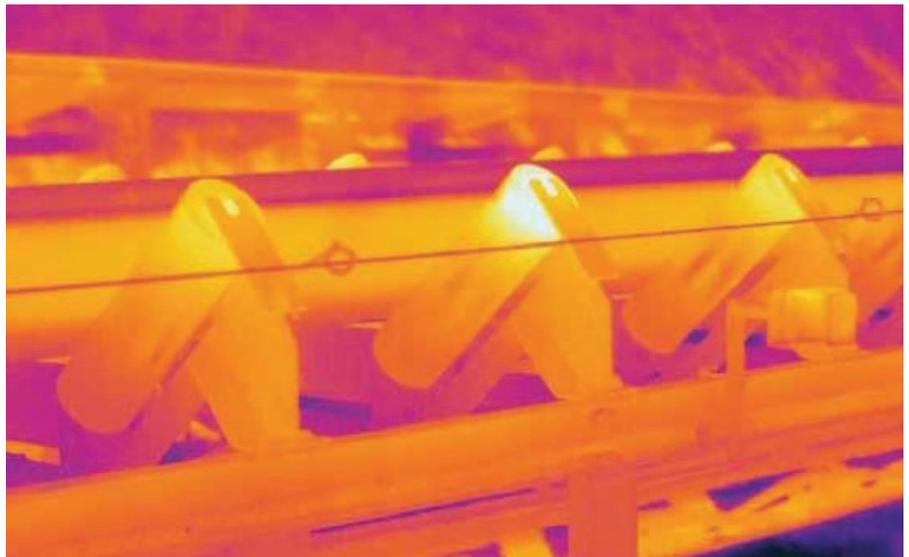
Figure 1: Conveyor bearing failure as seen with a thermal imaging camera..

Thermal imaging is the perfect tool to help with this by detecting early signs of failure by scanning for anomalies. Tiger-Sul uses thermal imaging to highlight issues and potential sources of ignition during manufacturing facility inspections, as shown in Figure 1.

Thermal equipment is often used within industry to highlight issues with mechanical systems to detect overheated bearings shown by high-temperature readings, demonstrating where strain has occurred on the motor. Thermography cameras can also detect lubrication issues and misalignment that could result in a reduction in workflow pace if not detected.

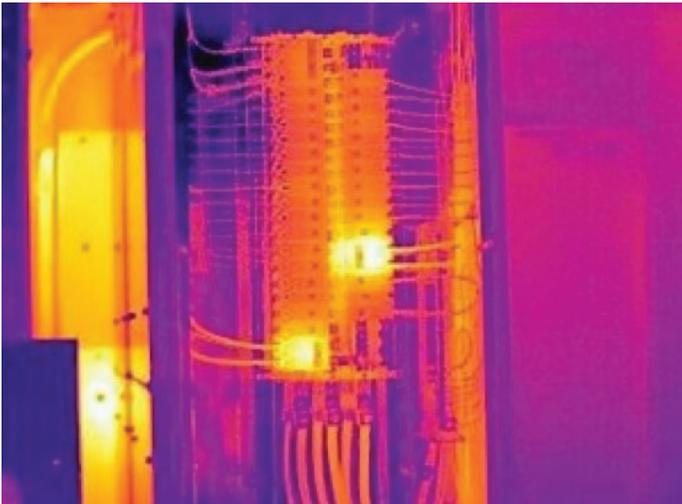
Figure 2: Electrical panel breaker failures as seen by thermal imaging.

Infrared cameras can be used to carry out low voltage inspections of electrical equipment by identifying temperature increases in electrical connectors. Loose connections result in potential arcing and/or increased heat generation. Locating the high temperature position provides opportunity to pinpoint and correct problem before failure occurs.

As demonstrated in Figure 2, thermography can also be helpful when conducting inspections of connectors carrying high voltages to detect issues. By identifying the temperature difference, you can then work out what actions need to be implemented before the problems occur. The image captured on the thermal camera will also help to clearly indicate where circuit breakers and power lines of high voltages are situated to help assess other potential issues.
